“A Coastal Condo Climate Risk Primer”

By: Albert Slap, President, Coastal Risk Consulting, and Dr. Randall Parkinson

July 2021

Climate Change, a Risk Multiplier

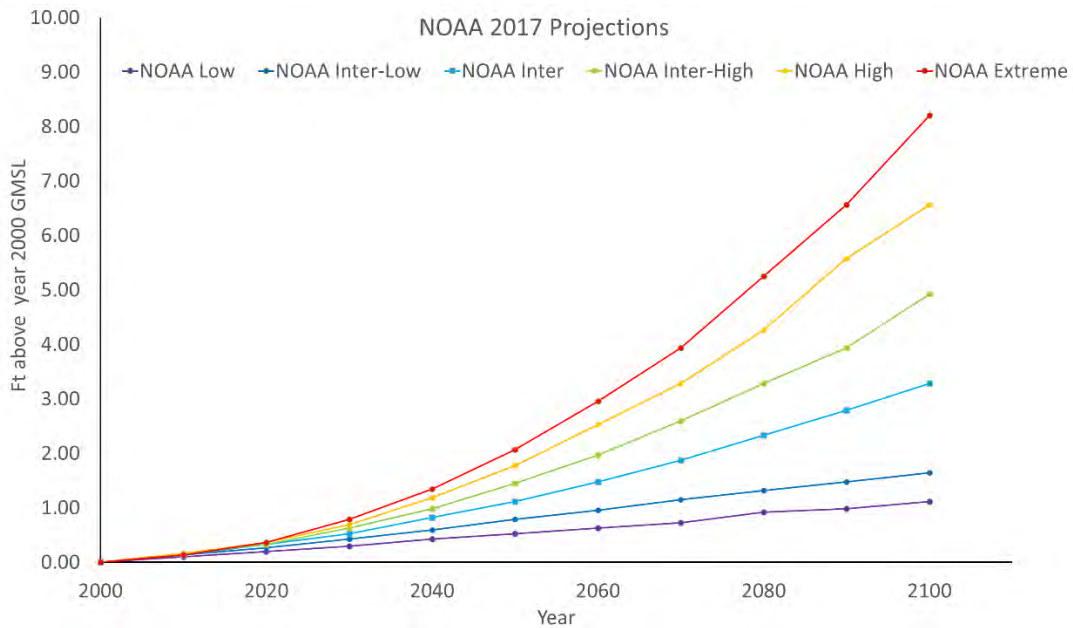
Figure 1. Sea-level rise projections as forecast by NOAA (2017).

Prior to the 1980s, it was not commonly known that sea-level was rising albeit at a very slow rate; almost imperceptible (<0.0787 inches per year). Many buildings that were constructed before then are still intact, having withstood the test of time. However, our climate has begun to change and more rapidly. Sea level is now rising at 0.13 inches per year and is expected to continue accelerating to as fast as 1 inch per year by the end of this century (Figure 1).

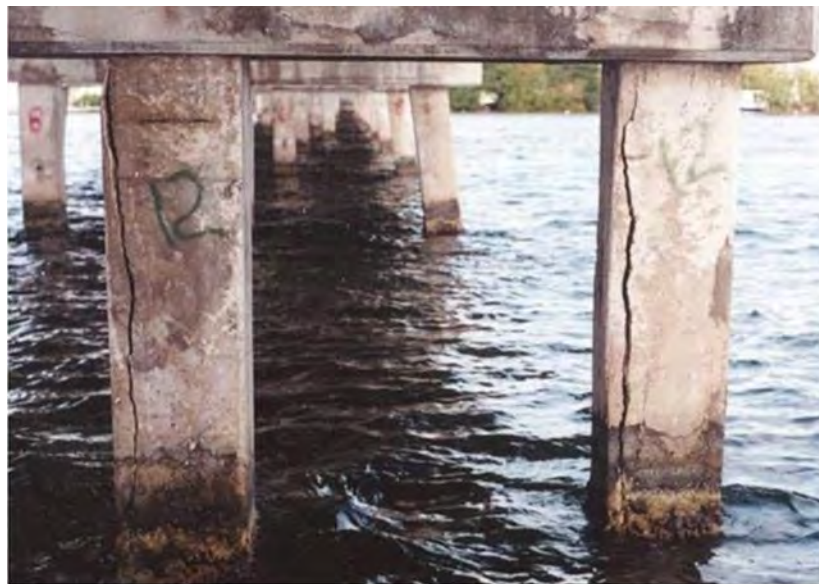
Figure 3. Structural integrity of pilings in seawater compromised by saltwater intrusion.

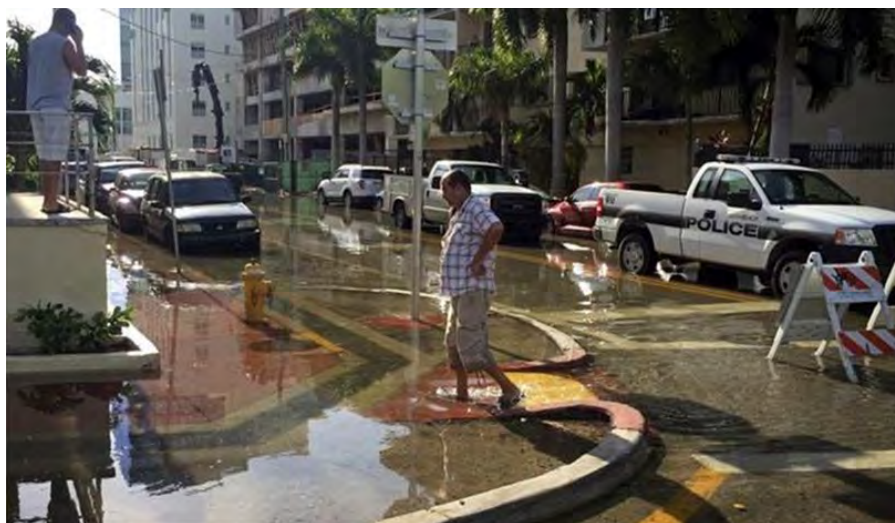
Figure 5. Saltwater bubbling onto the street from a stormwater drain during exceptional tide event.

level increases. It occurs when tides reach anywhere from 1 to 2 feet above the daily average high tide and start spilling onto streets (Figure 4) or bubbling up from storm drains (Figure 5).

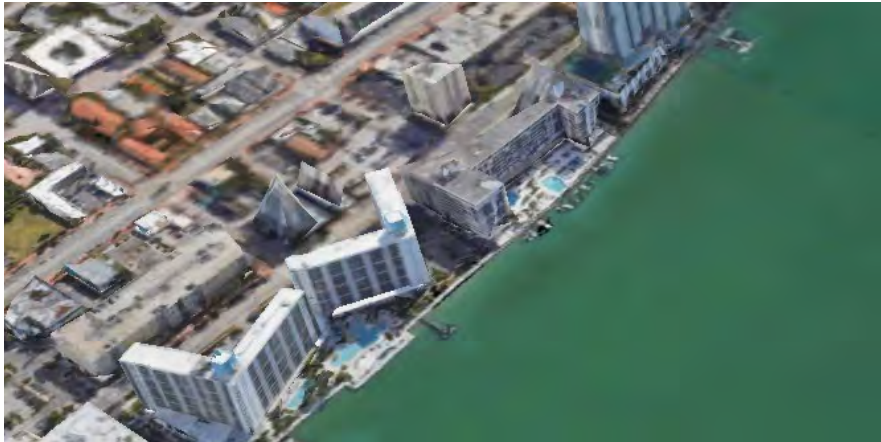
West Ave. Condos Miami Beach (Google Earth)

Modeling of Sea Level Rise flooding at West Ave. Condos by RiskFootprint™, www.riskfootprint.com

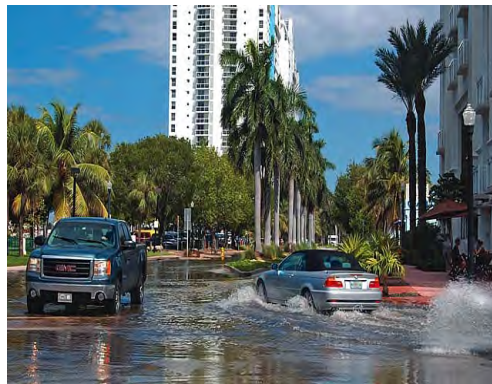
Image of King Tide or “sunny day” flooding, Miami Beach

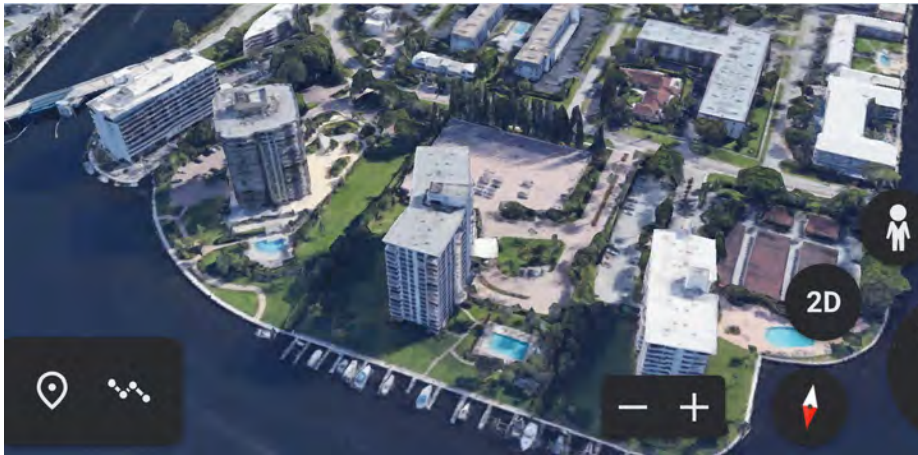
Lake Boca Condos, Boca Raton, FL (Google Earth)

Modeling of Pluvial or Heavy Rainfall flooding at Lake Boca Condos by RiskFootprint™, www.riskfootprint.com

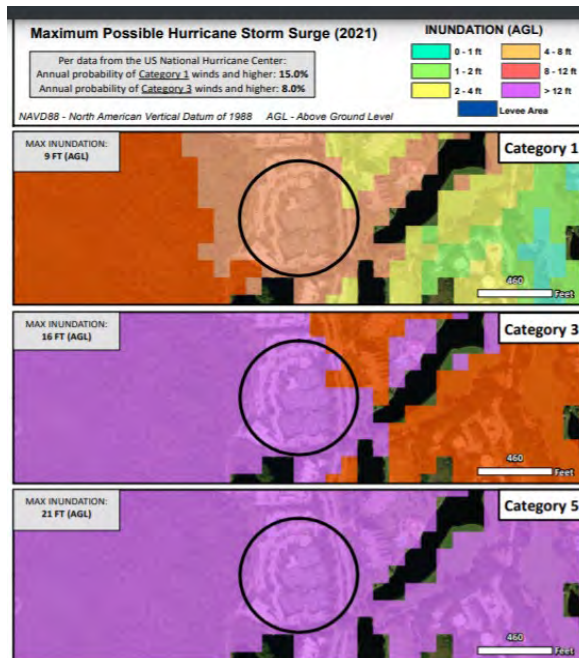
Modeling of Hurricane Storm Surge flooding at Naples, FL condos by RiskFootprint™, www.riskfootprint.com

Storm surge is the abnormal rise of water created by a strong storm. In South Florida, a significant storm surge is typically associated with a tropical storm. The storm surge results in temporarily higher water levels that recede after the storm has passed. Changing ground water levels and sea level rise water impacts storm surge heights. Higher water levels contribute to higher storm surges and potential wider area of land inundated by such a surge.

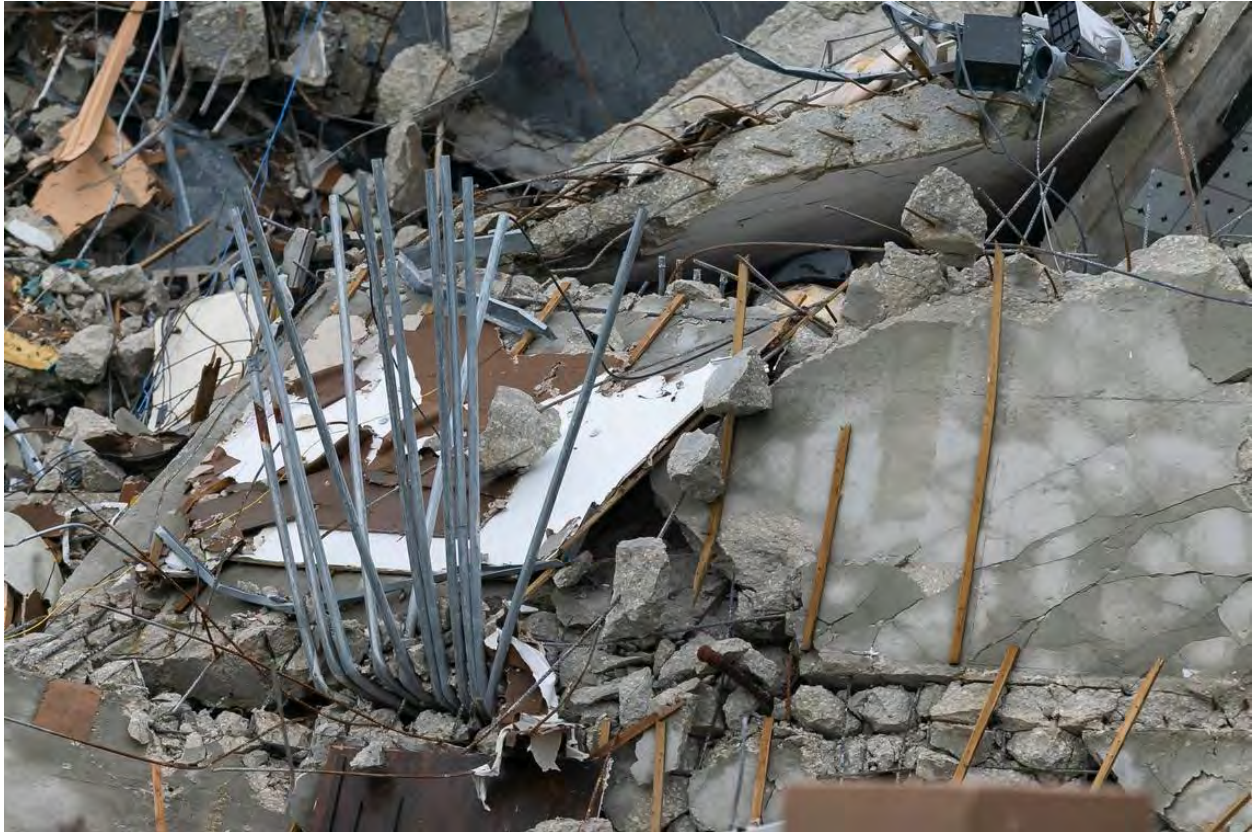
Rubble and debris of the Champlain Towers South condo can be seen in Surfside, Florida on Tuesday, July 6, 2021. The rubble shown here is from the front portion of the condo towers, which was demolished 11 days after the back part of the tower collapsed with people inside. (MATIAS J. OCNER | mocner@miamiherald.com)

Water, especially saltwater, can worm its way into concrete, creating pockets of air that eat away at the adhesive between the components of cement, eventually reaching (and destroying) the reinforcing steel rebar embedded within.

Corrosion from salt spray, storm surge and tidal flooding is an old foe in coastal areas, often the biggest and most expensive repair faced by aging buildings. Buildings constructed in the 1980s — before tougher codes and improved construction techniques — are particularly vulnerable. One pool maintenance worker told the Miami Herald the garage had standing water in it 36 hours before the building collapsed, and he was told that the underground pool maintenance room ran through a new water pump every two years to keep the room dry.

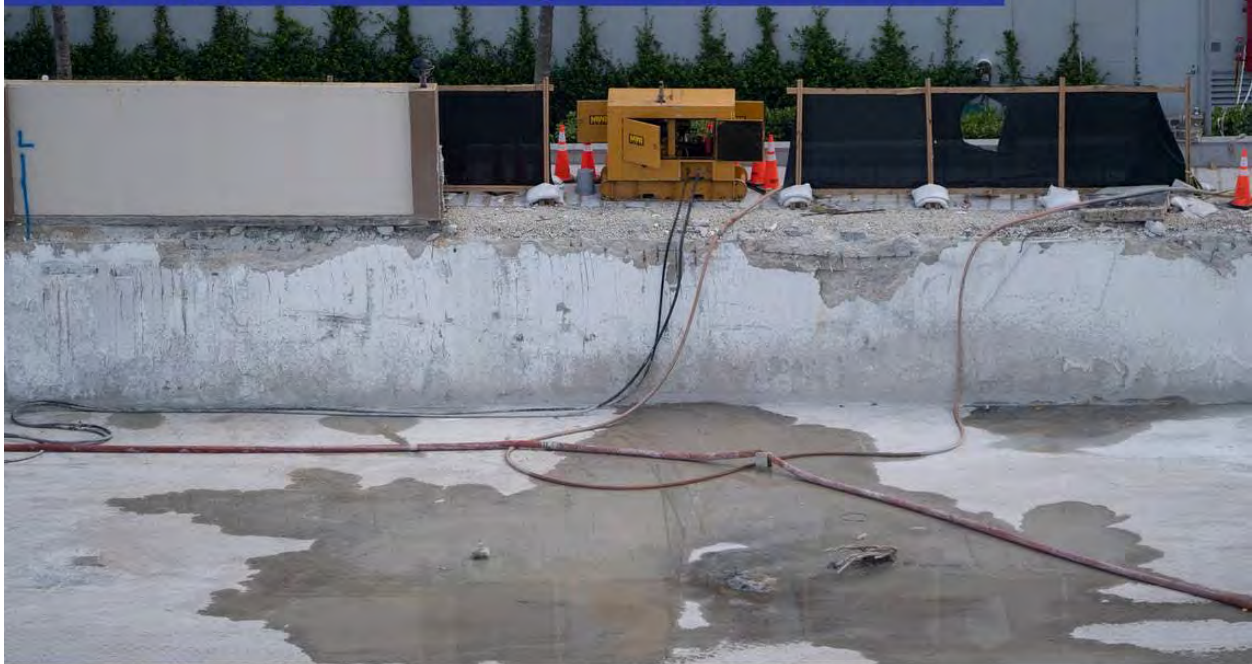
PHOTO TAKEN AT 4:44 p.m.
Preliminary observed tidal reading at 4:48 p.m.: -0.01 ft NAVD

Photos taken of the scraped-clean floor of Champlain Towers South show water pooling in the area.
(Robert Lisman)

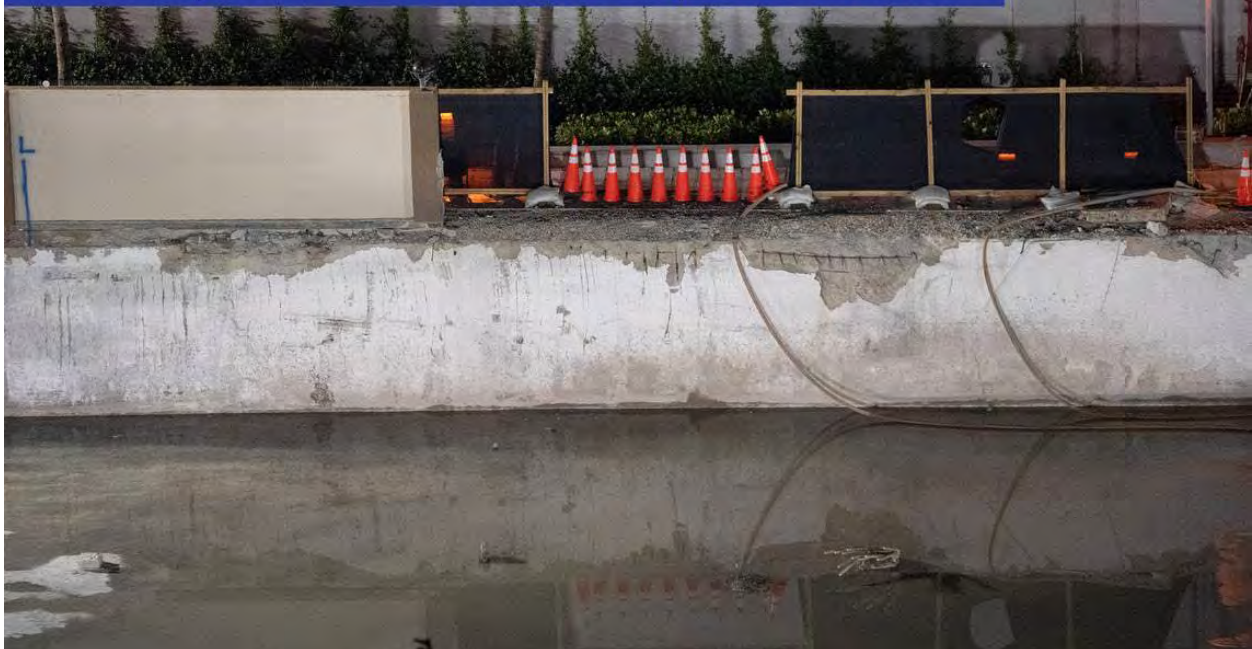
PHOTO TAKEN AT 11:28 p.m.
Preliminary observed tidal reading at 11:30 p.m.: -1.27 ft NAVD
